Port Kembla Berth 103 Dredging and Spoil Disposal

Fortnightly Turbidity Report 15 June to 28 June 2015

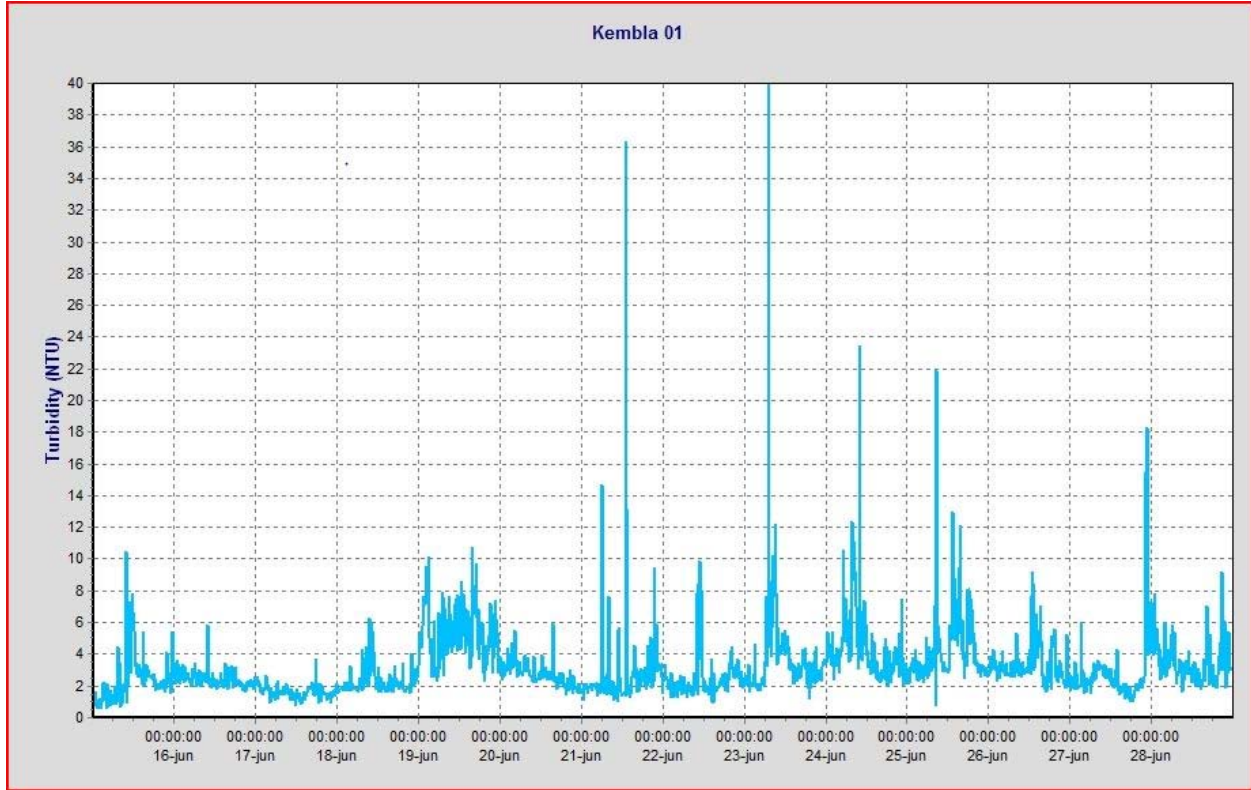
Kembla 01 located opposite Berth 102

Date	Time	NTU Level	Reason
19/6/15	0310	10.11	Unknown
19/6/15	1600	10.70	Outward vessel 424504
21/6/15	0610	14.69	Inward vessel 424583
21/6/15	1310	36.31	Outward vessel 424568
23/6/15	0710	43.21	Outward vessel 424456
23/6/15	0840	10.21	Inward vessel 424525
24/6/15	0520	10.56	Outward vessel 424525
24/6/15	0750	12.39	Inward vessel 424459
24/6/15	1010	23.46	Unknown
25/6/15	0850	21.92	Buoy serviced and cleaned
25/6/15	1330	12.97	Outwards vessel 424459
25/6/15	1550	12.14	Inwards vessel 424512
27/6/15	2250	18.28	Outwards vessel 424572

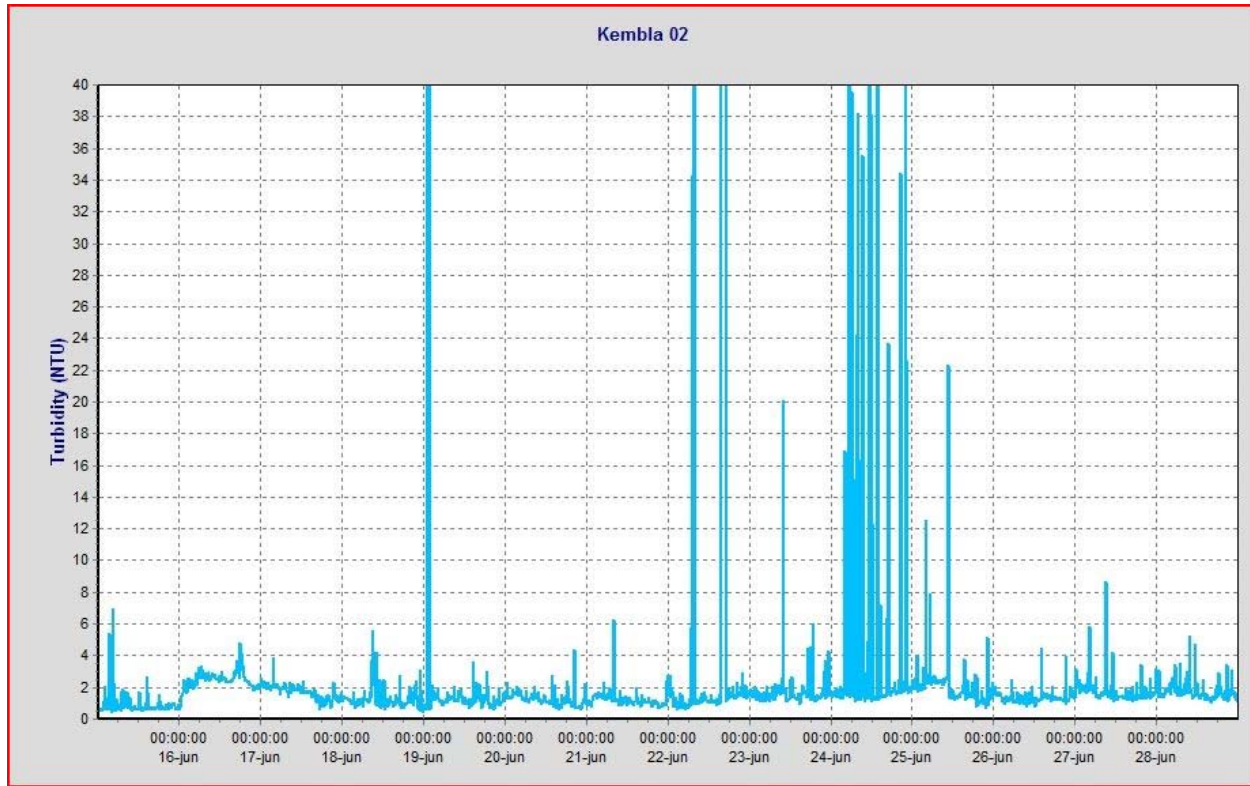
Kembla 02 located North East of the Spoil Disposal Ground

Date	Time	NTU Level	Reason
19/6/15	0120	59.14	Unknown
22/6/15	0720	34.26	Inward vessel 424579
22/6/15	1550	59.14	Diving works on Silt Screen
23/6/15	1010	20.12	Outwards vessel 424579
24/6/15	0410	16.82	Barge operations
24/6/15	0620	39.54	Barge operations
24/6/15	0800	38.19	Outwards vessel 424575
24/6/15	0830	16.33	Inwards vessel 424459
24/6/15	1130	59.14	Diving works on silt screen
24/6/15	1220	12.37	Inwards vessel 424521
24/6/15	1400	40.84	Outwards vessel 424580
24/6/15	1710	23.66	Unknown
24/6/15	2040	34.42	Unknown
24/6/15	2210	50.25	Unkown
25/6/15	1050	22.30	Buoy serviced and cleaned

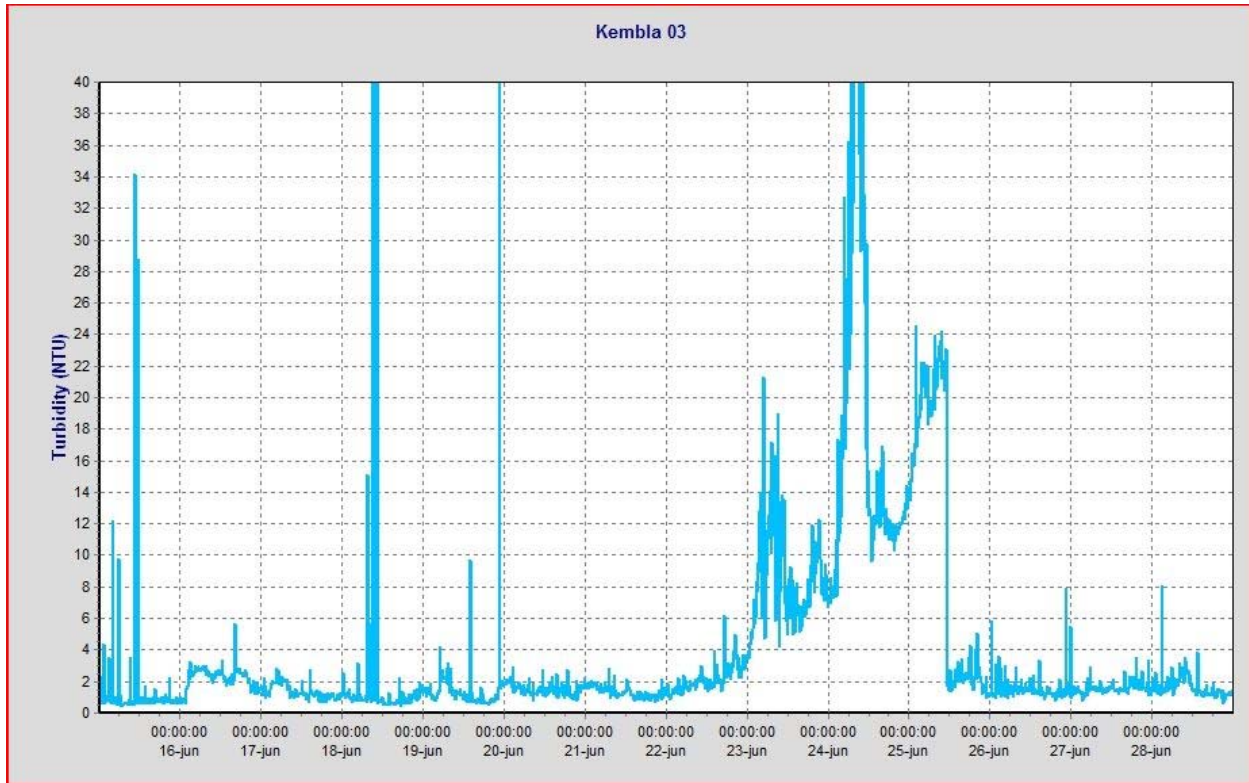
Kembla 03 located South West of Spoil Disposal Ground

Date	Time	NTU Level	Reason
18/6/15	0740	15.10	Inwards vessel 424573
18/6/15	0900	48.50	Inwards vessel 424544
19/6/15	2240	48.50	Inwards vessel 424481
23/6/15	0340	12.83	Buoy started to malfunction – fixed issue on 25/6/15
25/6/15	1120	23.05	Buoy serviced and cleaned

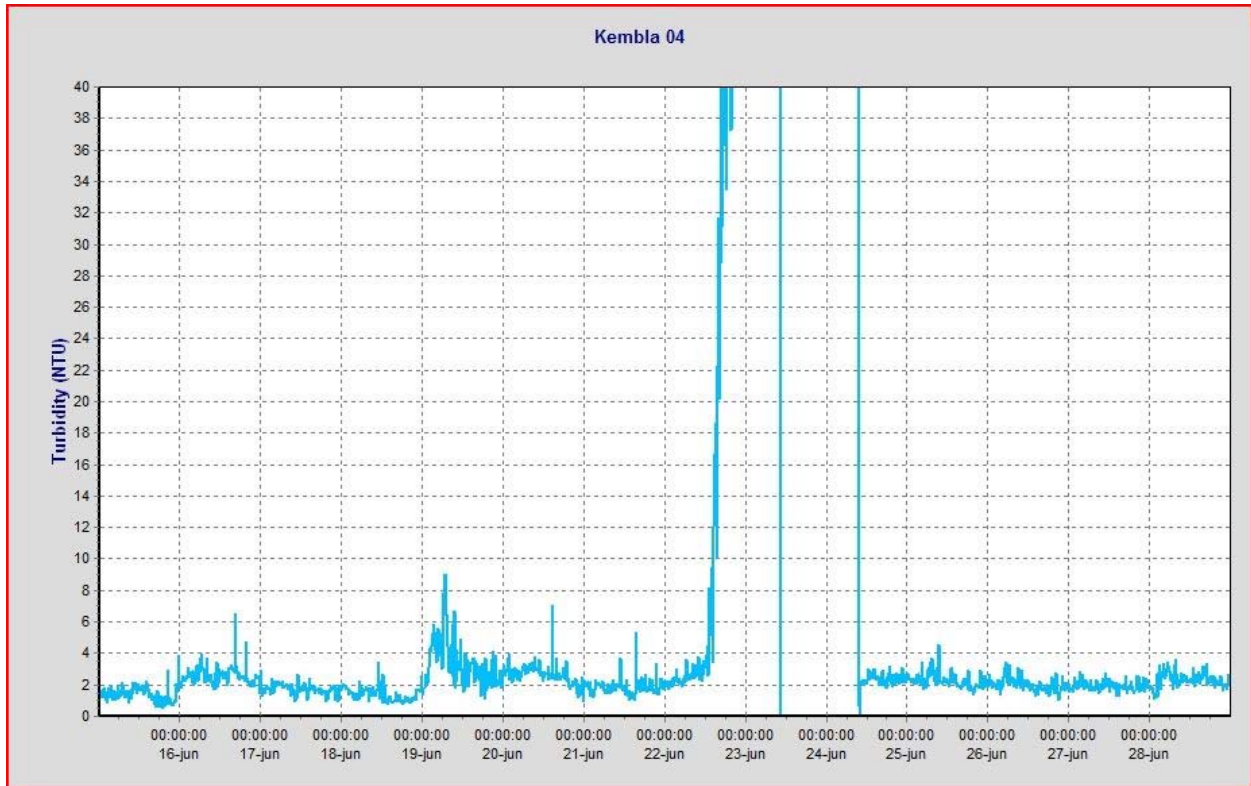
Kembla 04 located at the entrance to the outer harbour

Date	Time	NTU Level	Reason
22/6/15	1440	12.02	Sensor started to malfunction
23/6/15	1030		Sensor cleaned
23/6/15	1040		Sensor malfunctioned
24/6/15	0950		Buoy removed from water and sensor changed

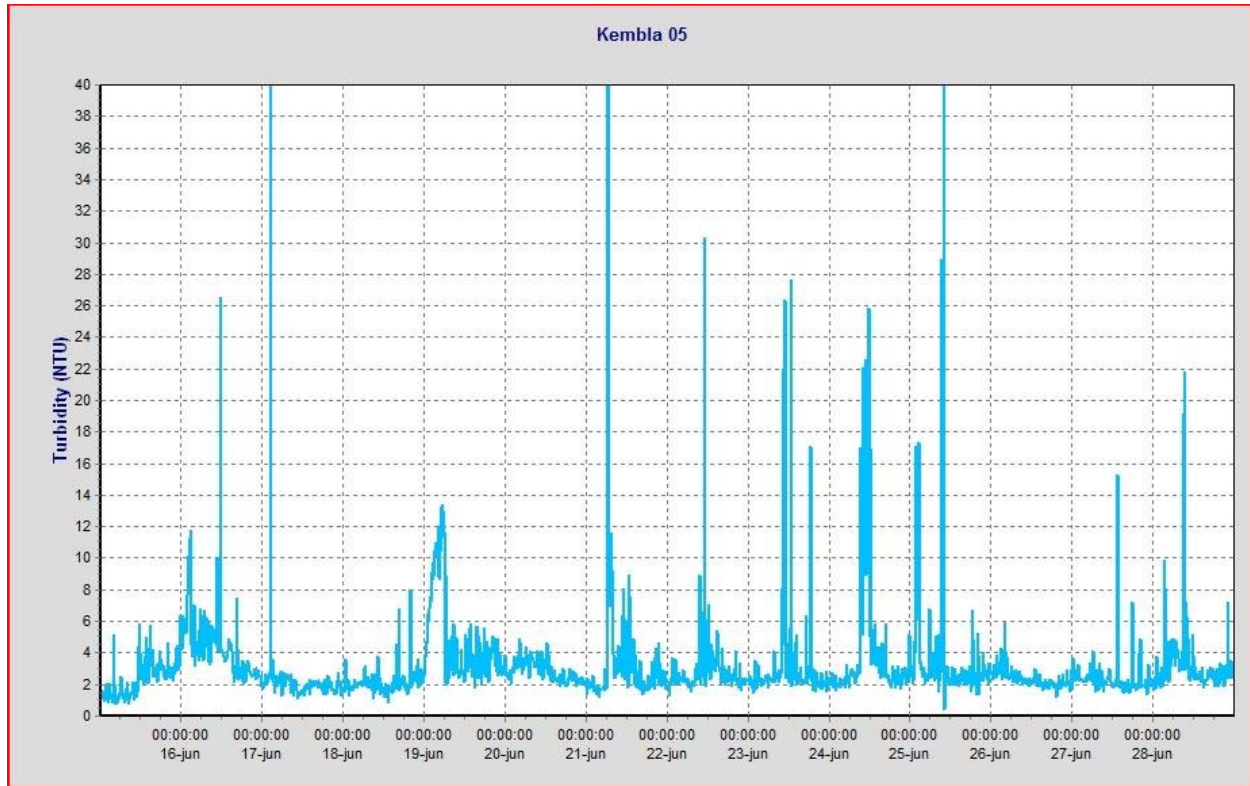
Kembla 05 located next to berth 113

Date	Time	NTU Level	Reason
16/6/15	0220	10.16	Inward vessel 424445
16/6/15	1140	26.51	Inward vessel 424528
17/6/15	0240	44.00	Inward vessel 424591
19/6/15	0300	10.22	Unknown
21/6/15	0630	51.75	Inwards vessel 424583
23/6/15	1100	26.35	Outwards vessel 424579
23/6/15	1250	27.68	Inwards vessel 424579
23/6/15	1840	17.10	Outwards vessel 424233
24/6/15	0930	17.03	Inwards vessel 424459
24/6/15	1150	25.83	Inwards vessel 424521
25/6/15	0240	17.35	Unknown
25/6/15	0930		Buoy serviced and cleaned
27/6/15	1340	15.28	Unknown
