Port Kembla Berth 103 Dredging and Spoil Disposal

Fortnightly Turbidity Report 29 June to 12 July 2015

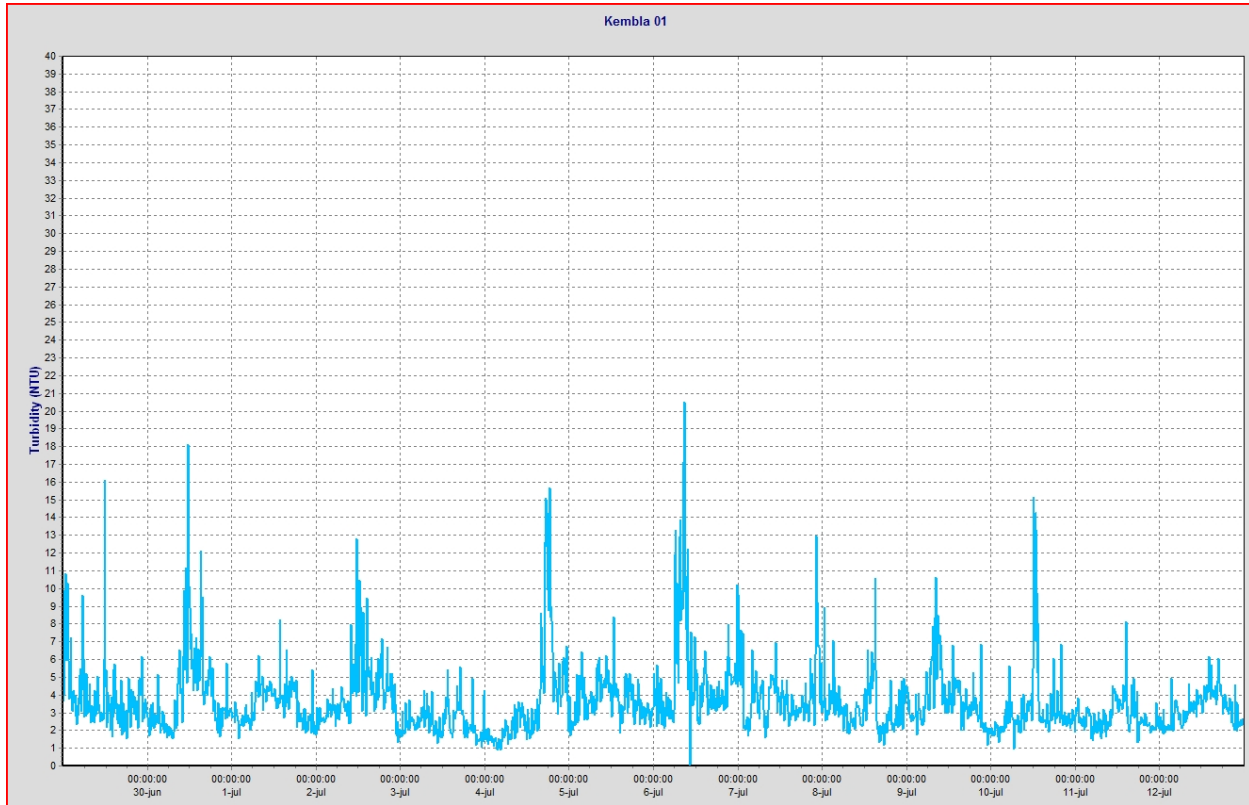
Kembla 01 located opposite Berth 102

Date	Time	NTU Level	Reason
29/6/15	0050	10.86	Inward Vessel 424574
	1200	16.07	Outward Vessel 424565
30/6/15	1140	18.14	Inward Vessel 424630
	1520	12.12	Outward Vessel 424531
2/7/15	1140	12.81	Outward Vessel 424630
4/7/15	1720	15.09	Outward Vessel 424722
	1840	15.65	Inward Vessel 424634
6/7/15	0740	13.84	Outward Vessel 424634
	0850	20.53	Buoy removed from water and serviced and cleaned
	2350	10.21	Unknown
7/7/15	2220	12.96	Inward Vessel 424680
8/7/15	1510	10.59	Uknown
9/7/15	0830	10.60	Inward Vessel 424748
10/7/15	1210	15.13	Inward Vessel 424714

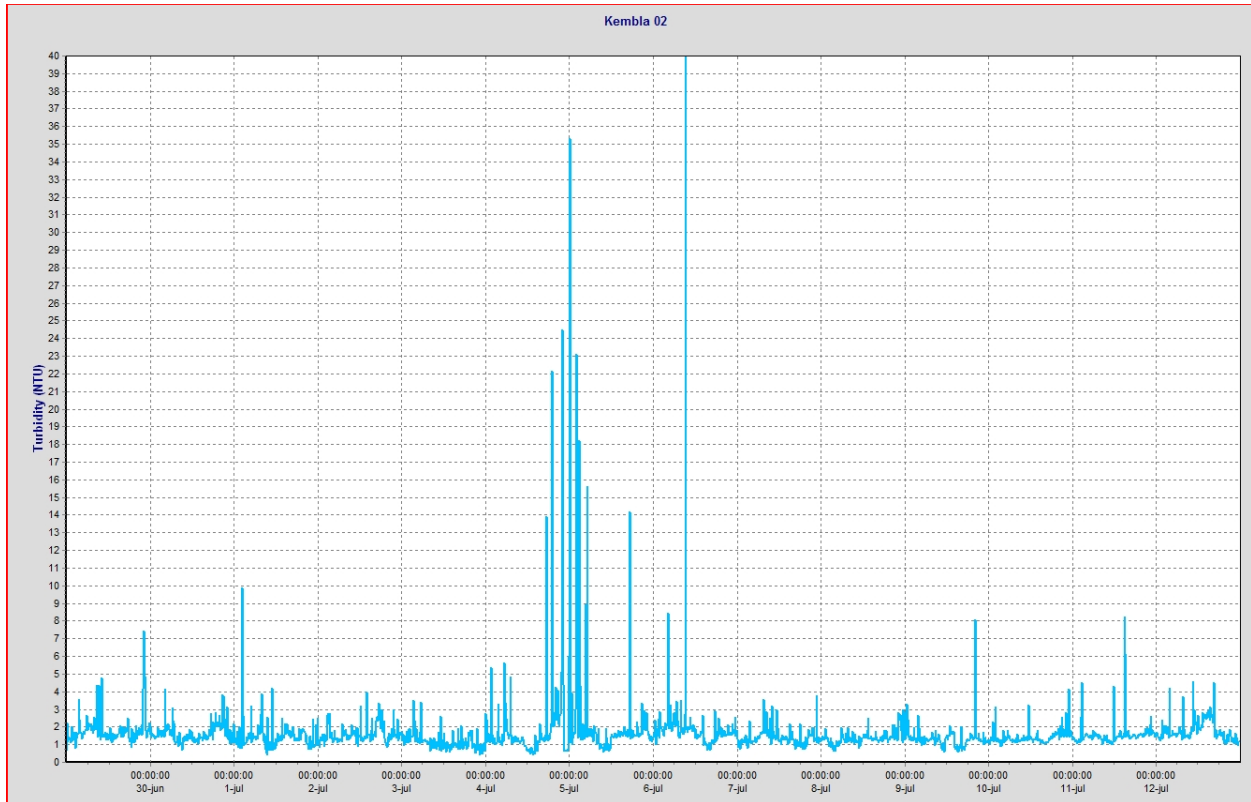
Kembla 02 located North East of the Spoil Disposal Ground

Date	Time	NTU Level	Reason
4/7/15	1730	13.93	Barge dump near curtain
	1910	22.14	Heavy Biofouling detected
	2200	24.49	Heavy Biofouling detected
5/7/15	0010	35.35	Heavy Biofouling detected
	0210	23.13	Heavy Biofouling detected
	0250	18.23	Heavy Biofouling detected
	0510	15.61	Heavy Biofouling detected
	1720	14.16	Heavy Biofouling detected
6/7/15	0920	59.94	Buoy removed from water for servicing and cleaning

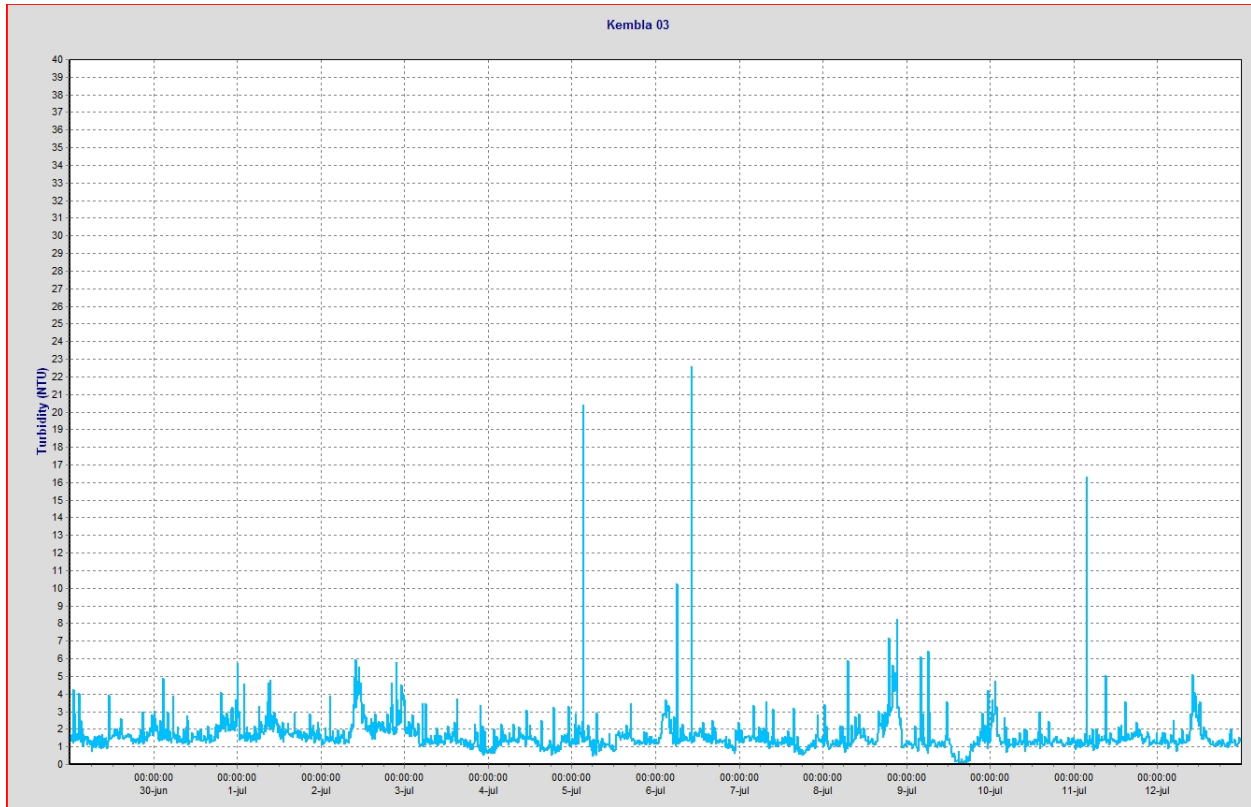
Kembla 03 located South West of Spoil Disposal Ground

Date	Time	NTU Level	Reason
5/7/15	0320	20.40	Unknown
6/7/15	0610	10.26	Unknown
	1020	22.57	Buoy removed from water fro servicing and cleaning
11/7/15	0340	16.33	Unknown

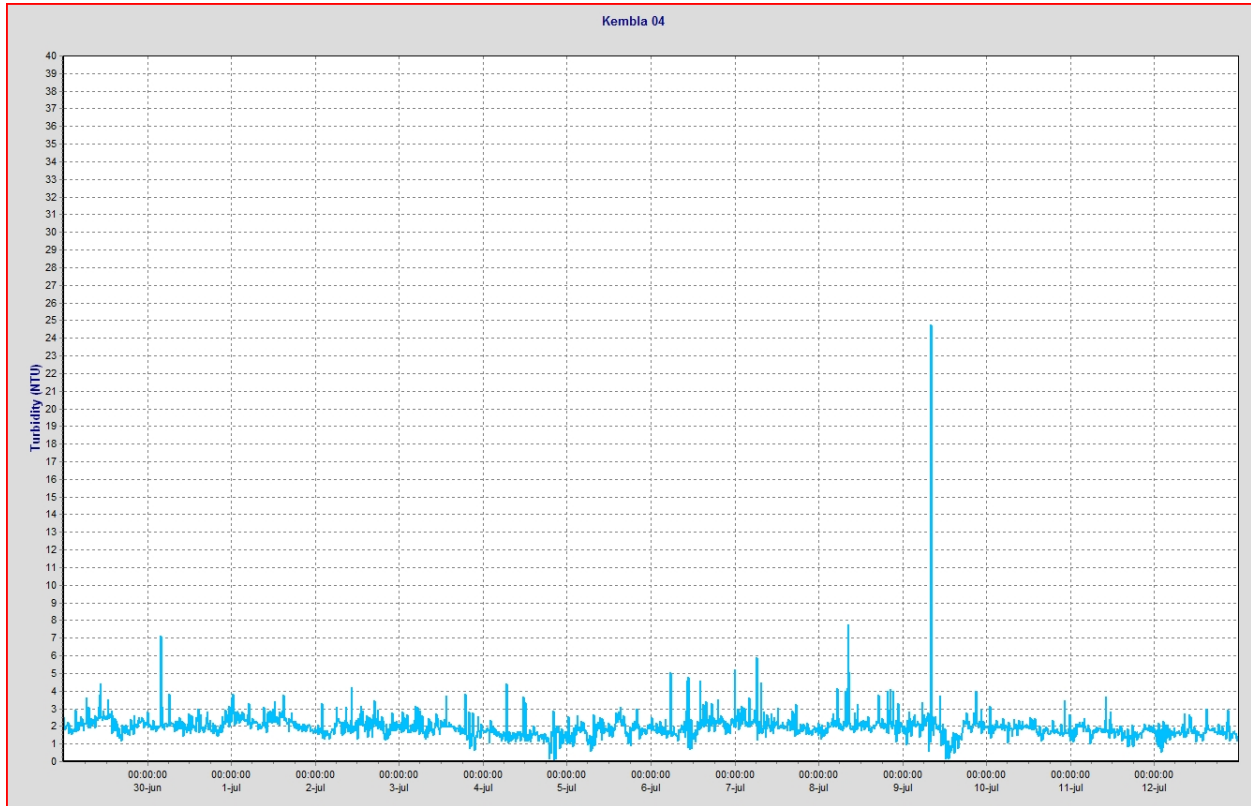
Kembla 04 located at the entrance to the outer harbour

Date	Time	NTU Level	Reason
9/7/15	0810	24.74	Fisherman sighted working close to the buoy by Survey Boat Crew

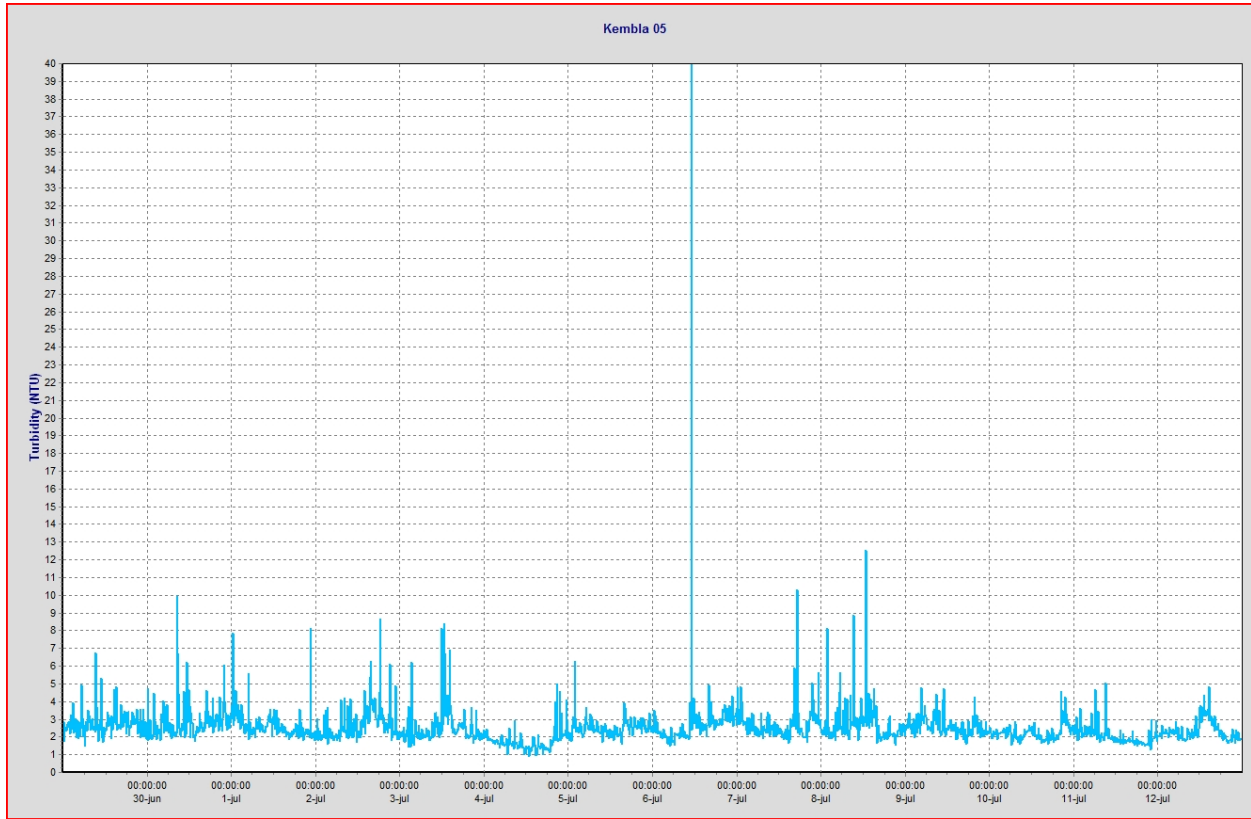
Kembla 05 located next to berth 113

Date	Time	NTU Level	Reason
6/7/15	1110	53.56	Buoy removed from water for servicing and cleaning
8/7/15	1250	12.52	Unknown
